Disaster Mitigation for Historic Structures: Protection Strategies

Prepared by 1000 Friends of Florida on behalf of the Florida Department of State, Division of Historical Resources and the Florida Division of Emergency Management

AUGUST 2008

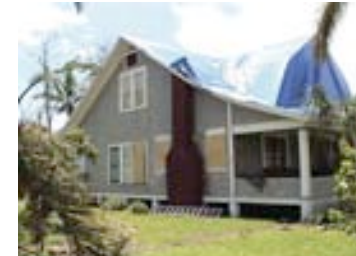
A roof tarp provides temporary stabilization.

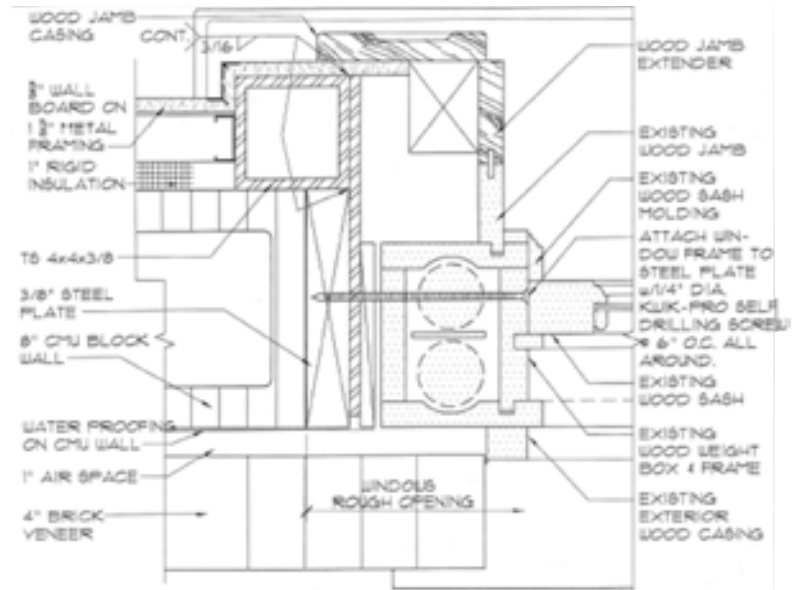
A) Elevation of Window on Interior Side of Opening; B) Reinforced Window Jam Detail; C) Window Sill Detail

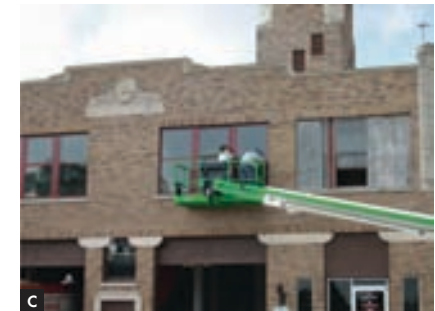
A) North-Window; B) West Wall After New Window; C) Window Installation on Facade

The selected product, Jamestown 175, impact glass, windows met the project criteria. There were two installation conditions, the first floor windows were installed with masonry clips. The second floor windows were installed on pressure treated 2 x framing installed within the original brick masonry "pocket".

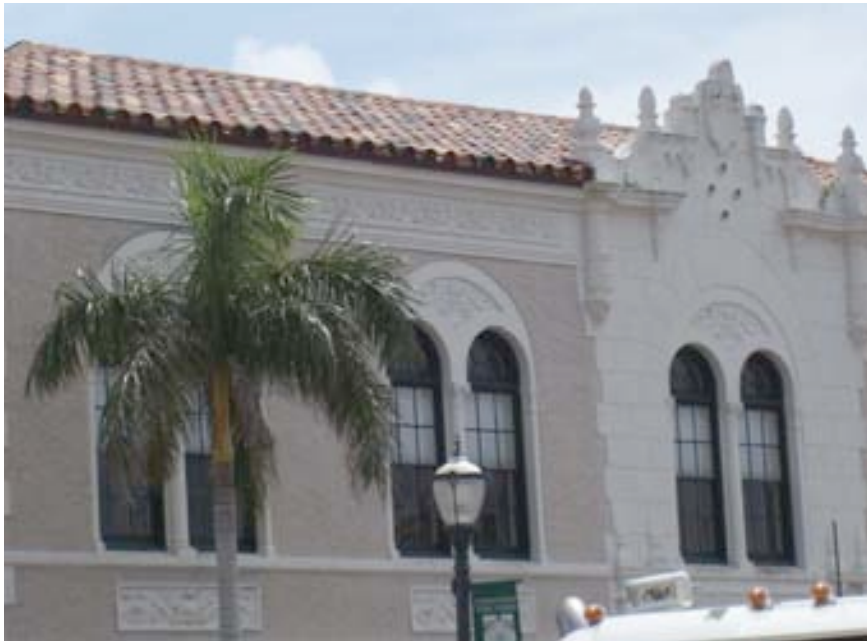
**Old City Hall****Downtown Fort Pierce**

Tiles installed on historic 1925 City Hall are a color mixture or "blend" of 40% Clay Red, 20% 165-01, 20% Impressionist Tuscan, 10% Empire Green with Ebony Mist and 10% Brookville Green-High Gloss.

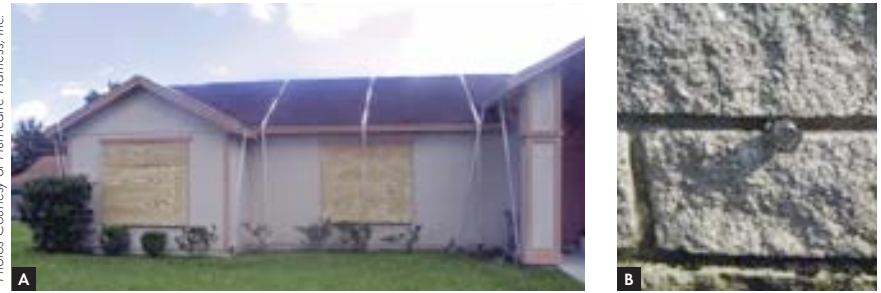
A) Roof straps installed on a home.; B) Roof strap anchor.
