The Griffin

A publication of the Heritage Trust of Nova Scotia

HERITAGE RESTORATION SEMINAR -- JUNE 16, 1990

Heritage Starts at Home

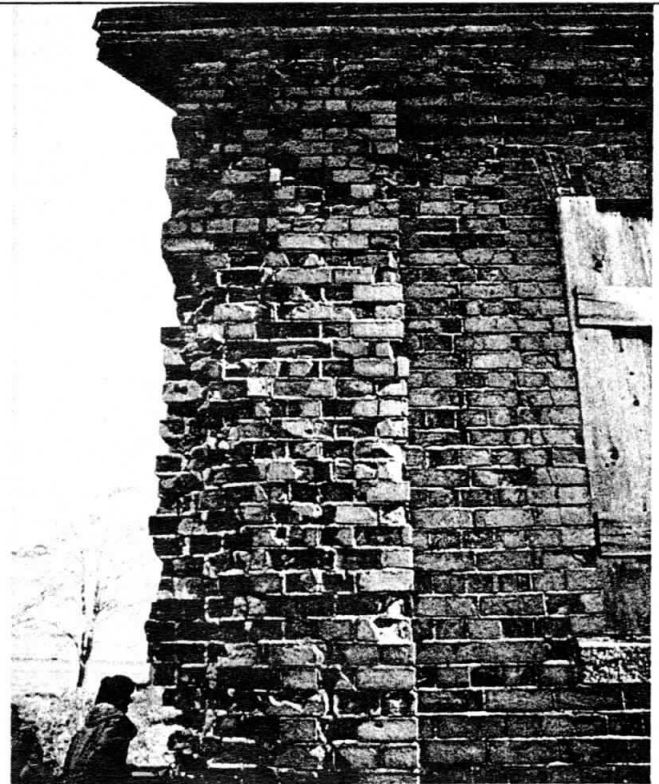
Severely damaged English bond brickwork, George Island, Halifax, N.S. ca. 1886. Note how mortar is standing up to ice damage better than the bricks.

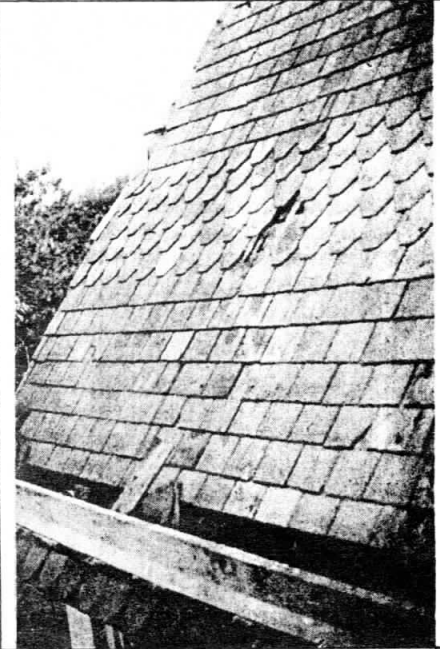
Loose slates indicate that roof nails are badly rusted. Major repairs are indicated.

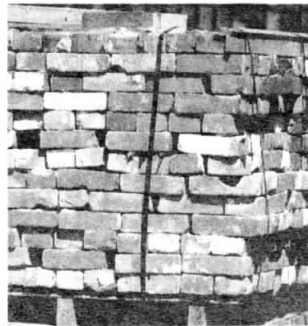
This load of bricks awaits recycling in a renovation job. Bricks from interiors and exteriors are mixed together.

Recycled or salvaged bricks usually have an attractive combination of warm red-orange colours, pleasant texture, and a slight irregularity often associated with hand-manufacture.

Unfortunately, salvaged bricks can suffer from two problems. When old bricks were manufactured they were subject to a wide range of firing temperatures: some were over-fired and partially melted to form a glass-like surface (known as clinkers); others were under-fired and remained soft and very porous (known as salmons). The third-rate salmons could be used in the interiors of walls and in interior partitions where no damp could
